Manhole Inspection Summary

Manhole # S21AA_009MH

Insp Date: **9/11/07 9:49 AM**

Location Address: **1723 LAFAYETTE AVE**

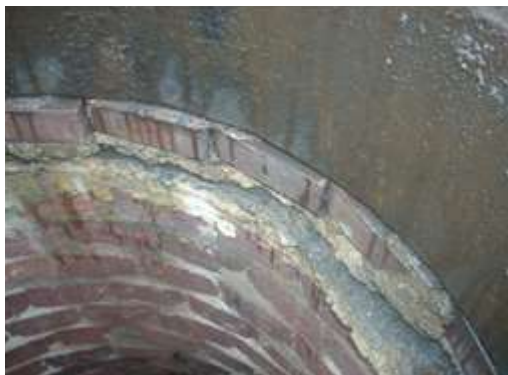
Defect 3

Condition: ☐ Sound ☐ Cracked ☐ Root Intrusion ☒ **Loose Brick** ☐ Deteriorated

LOOSE BRICKS IN THE CHIMNEY

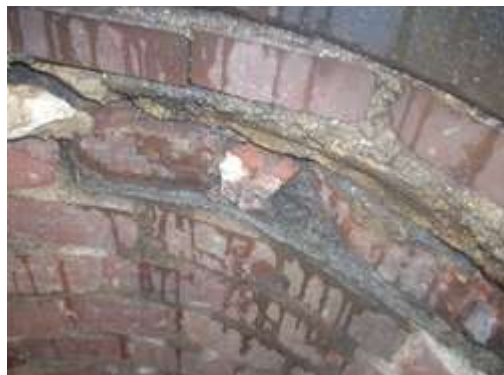
Defect 2

Condition: ☐ Sound ☐ Cracked ☐ Root Intrusion ☐ Loose Brick ☒ **Deteriorated**

DETERIORATED CORBEL

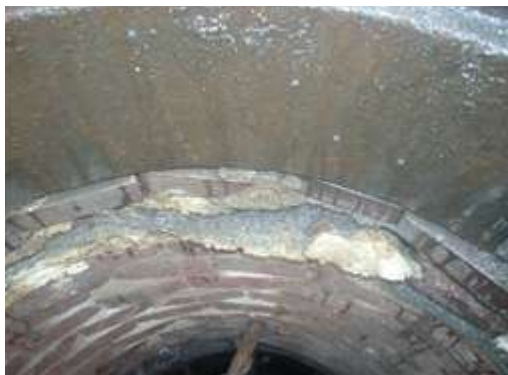
Defect 1

Offset: **1** (in.)

FRAME OFFSET

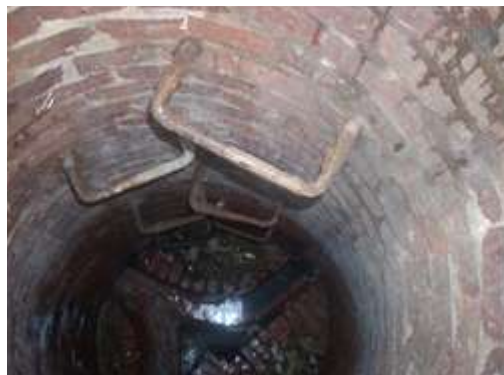
Defect 4

Count: **6** Missing: **0** ☒ **Corroded**

CORRODED STEPS

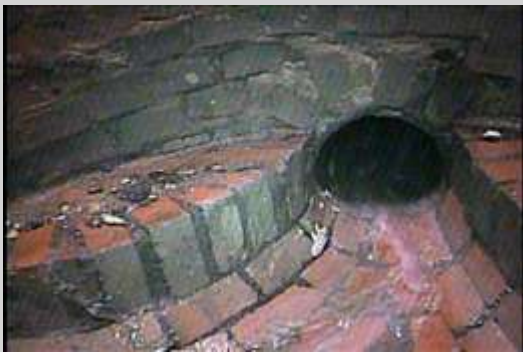
12 O'Clock Outflow

Infiltration: ☐ None ☐ Joint ☐ Cracks ☐ Mortar ☐ Roots ☒ **Wall**

INFILTRATION OF THE BARREL OVER THE
PIPE

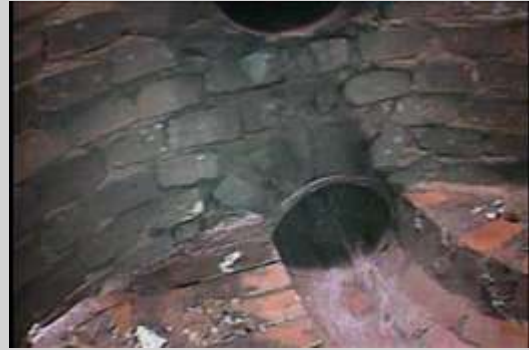
CORRODED STEPS
